Right atrial ghost following device extraction for infective endocarditis

Victoria Pettemerides MBBS BSc and Anita Macnab MBChB FRCP

Manchester Foundation Trust, Wythenshawe Hospital, Manchester, UK

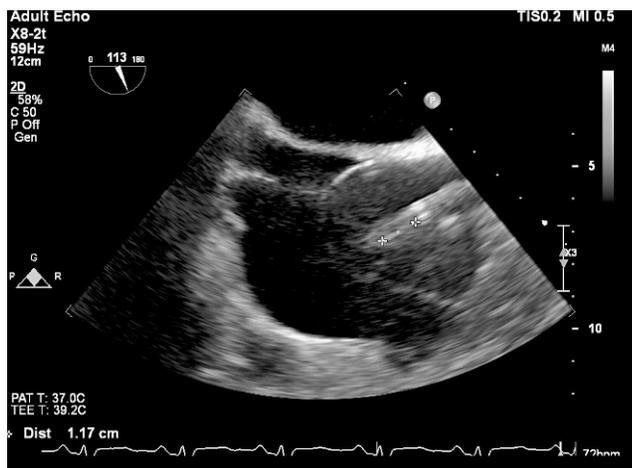
A 64-year-old male required extraction of a dual chamber implantable cardioverter defibrillator (ICD) due to lead endocarditis. Blood cultures were positive for *Staphylococcus lugdunensis*. Transoesophageal echocardiography (TOE) demonstrated a 11.7 mm vegetation attached to the right ventricular (RV) lead (Fig. 1 and Video 1). No vegetation was identified on the right atrial (RA) lead. Device extraction took place using TOE guidance. It was uncomplicated, but at the end of the procedure a cast-like structure was seen in the right atrium thought to represent fibrous or infective debris which had been encasing one of the leads (Fig. 2 and Video 2). All lead insulation from the extracted leads was intact. Device lead endocarditis is an indication for complete removal of the pacemaker system and intra-procedural imaging such as TOE is strongly recommended during device

Figure 1
Pre-extraction TOE, bi-caval view. A vegetation is seen attached to the RV lead as it enters from the SVC at the RA junction.

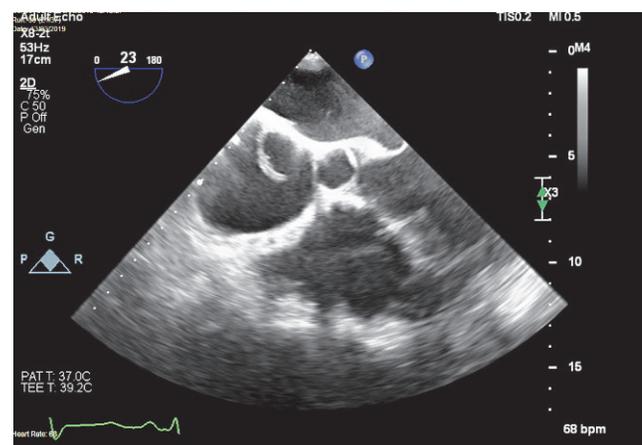
extraction to assess for complications which may lead to haemodynamic instability (1). The presence of residual debris or ghosts in the RA or superior vena cava (SVC) following lead extraction has an incidence of 8–14% (2, 3), occurring more commonly with infected leads. There is no specific therapy when this is identified, but it has been associated with higher mortality (3). Its presence ought to be documented at the time of extraction.

Figure 2
Post-extraction TOE 5-chamber view. The echo-free space represents the now extracted lead, leaving behind this fibrous cast in the RA.
