CASE REPORT

Transesophageal echocardiographic imaging of multiple complications following mitral valve replacement

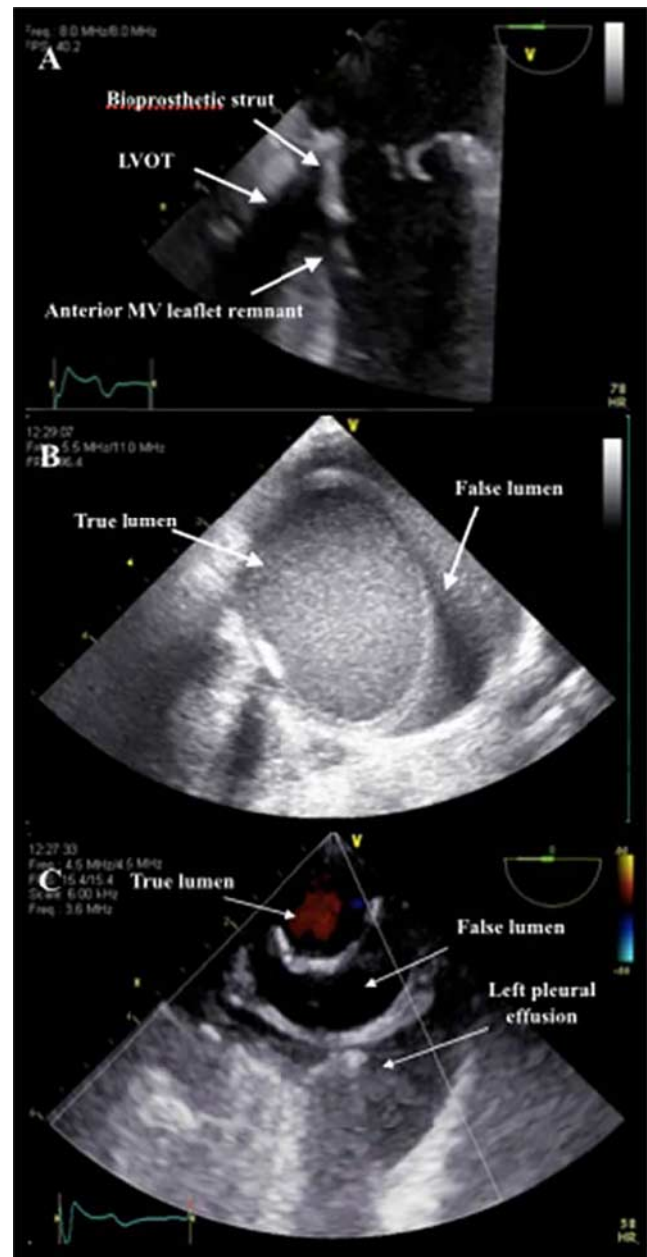
Figure 1
(A) Mid esophageal five-chamber view demonstrating LVOT obstruction from a bioprosthesis strut and anterior leaflet remnants. (B) Epiaortic ultrasound showing dissection of the ascending aorta. (C) Short axis view of the descending aorta with colour-flow Doppler to identify the true lumen of the aortic dissection. LVOT, left ventricular outflow tract; MV, mitral valve.

trial of weaning from CPB, a type A aortic dissection was visualized (Fig. 1B and C). After appropriate cooling, the ascending aorta and hemiarch were replaced using a 28 mm graft. A total circulatory arrest time of 21 min was recorded. Afterwards, separation from CPB was established

The decision to return on CPB for a second MV replacement was based on TEE findings of a LVOT obstruction from the strut of the bioprosthetic valve and anterior leaflets remnants. This is a well described phenomenon in the literature (1). Preservation of subvalvular apparatus maintains LV function and reduces the risk of myocardial rupture; however it harbours the potential for

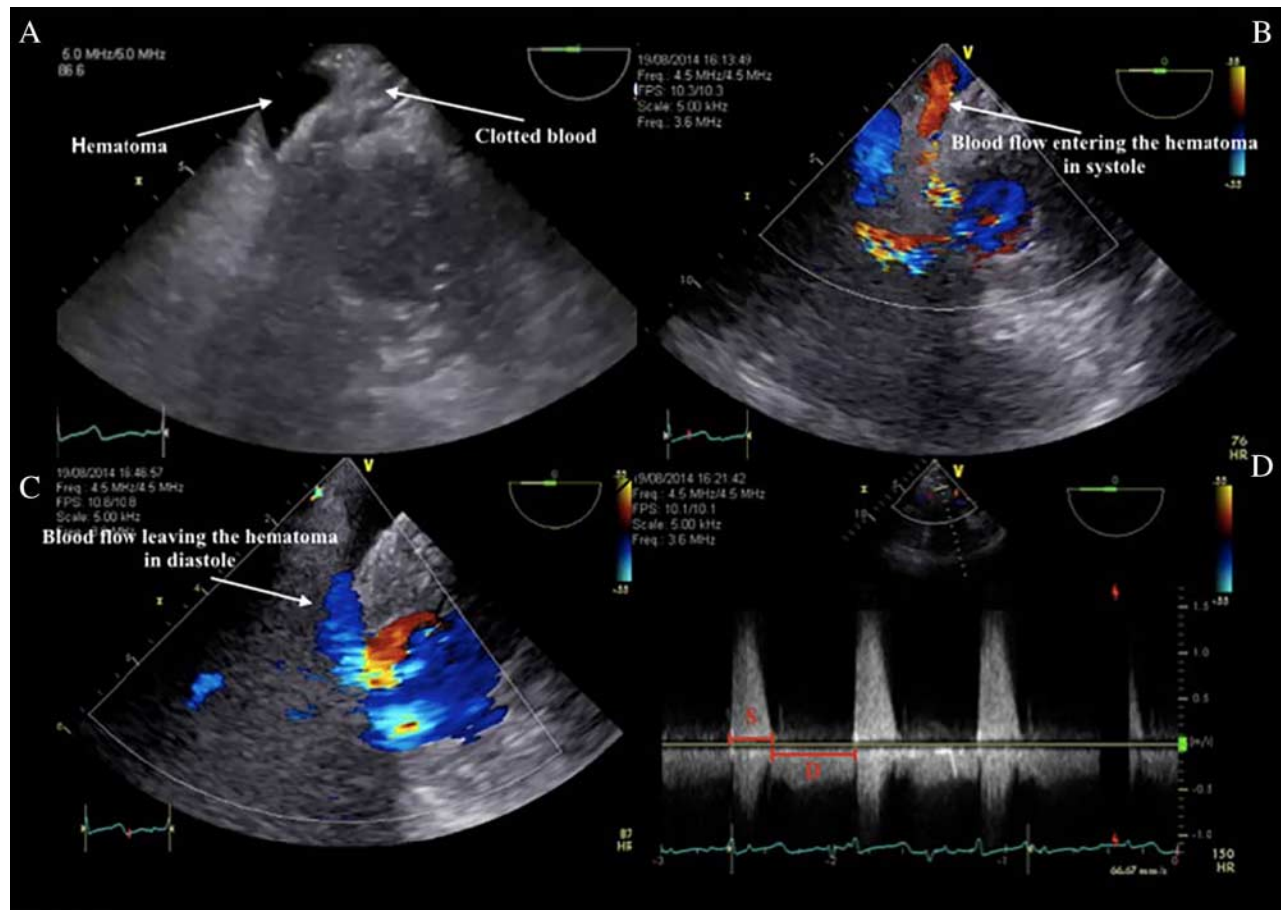
Figure 2

(A) Transgastric mid-papillary views demonstrating a hypoechoic density, i.e., pericardial haematoma adjacent to clotted blood.
(B) CF Doppler demonstrating blood flow entering the haematoma.
(C) CF Doppler demonstrating blood flow leaving the haematoma.

(D) CW Doppler showing the timing of blood flow through the LV rupture relative to the cardiac cycle. Blood flow is entering the haematoma in systole and leaving the haematoma in diastole. LV, left ventricle; CF, colour-flow; CW, continuous wave; S, systole; D, diastole.

for a second time. However, significant bleeding originating from the posterior aspect of the heart occurred and was associated with hemodynamic instability. The surgical team suspected a potential injury to the atrioventricular groove (AVG). A retroflexed mid-esophageal four-chamber view revealed a compressed coronary sinus (CS) measured at 5 mm, which prompted further examination of the AVG (Video 2). Ventricular rupture and a pericardial haematoma were visible from the trans-gastric short axis views. Colour-flow (CF) Doppler easily identified a jet dissecting through the posterior ventricular free wall. There was a large amount of blood flow entering the haematoma in systole, and leaving the haematoma in diastole CW Doppler confirmed the pattern of flow respective to the cardiac cycle (Fig. 2 and Video 2).

In our case, bleeding was identified in the mid-ventricular region of the posterior wall. TEE examination confirmed a mid-ventricular rupture near the ventricular septum extending to the LV inferobasal segment with flow entering the pericardial space in systole, as documented by continuous wave Doppler. An echo-lucent haematoma was also visualized adjacent to clotted blood in the posterior region. The most likely etiology of the bleeding was a type 3 LV rupture of the posterior wall by penetration of a valvular strut.
